August 18, 2005

LBP Assessment Results

Strata Environmental Resource

Property ID # 347 / 3539 Williams Street

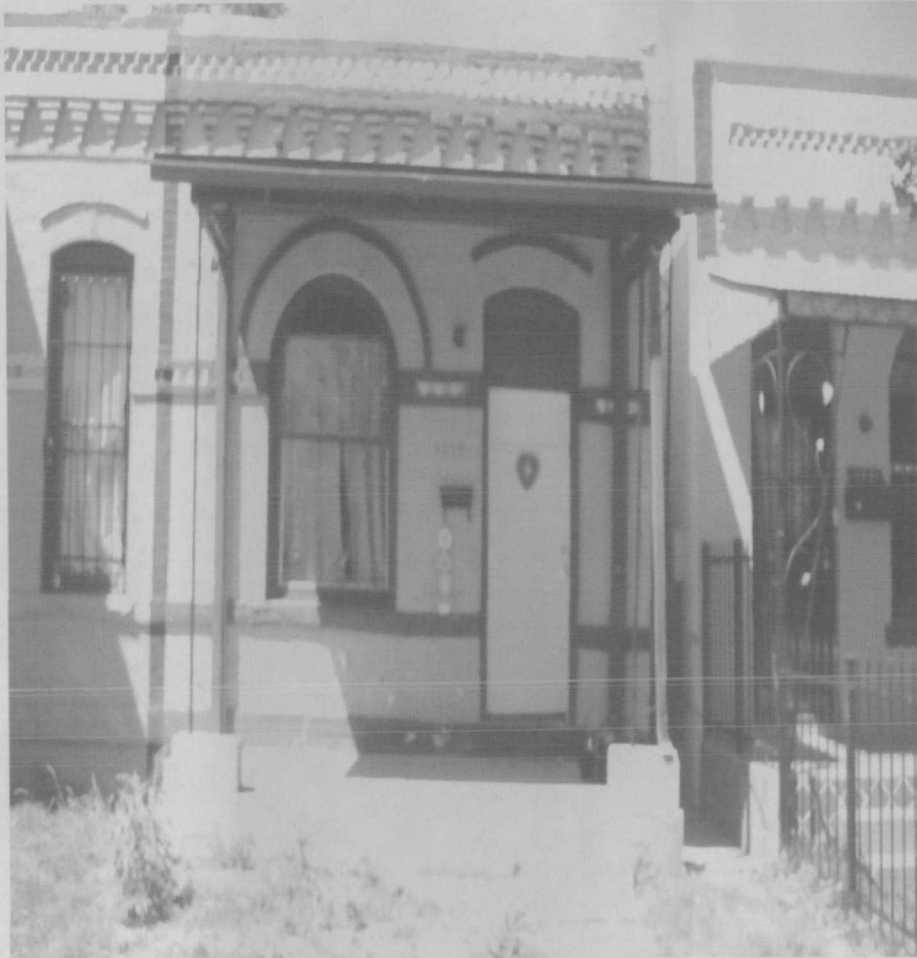
East exposure of house

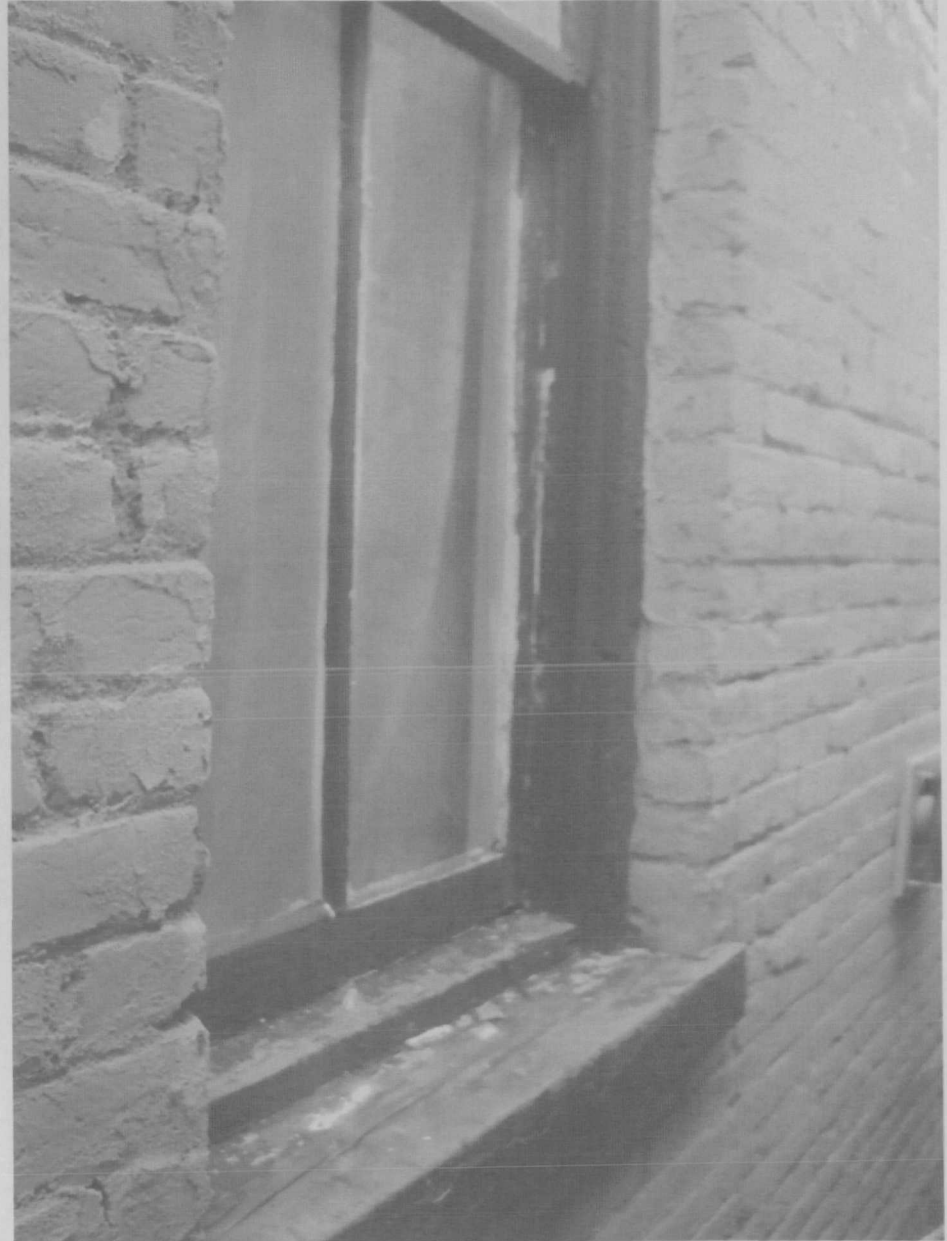
North exposure wood window frames contain peeling lead paint
